# **Navajo Abandoned Uranium Mine**

## **Site Screen Report**

### **Jackpot No. 1 AUM Site**

#### **Navajo AUM Western Region**

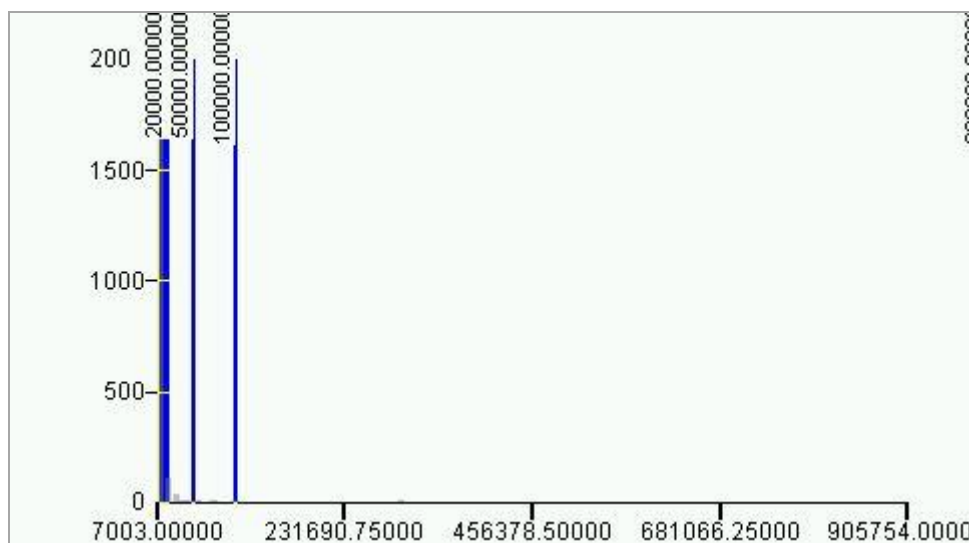
The following chart and statistics were generated by ESRI ArcGIS 9.3.1, and show the general distribution of the site gamma radiation measurements. The horizontal X axis represents the gamma radiation reading levels in cpm (lowest levels to the left). The vertical Y axis represents the frequency of each gamma radiation level.

Count:	2000
Minimum:	7003.00000
Maximum:	905754.00000
Sum:	46597860.00000
Mean:	23298.93000
Median:	11215.00000
Standard Deviation:	69213.15414

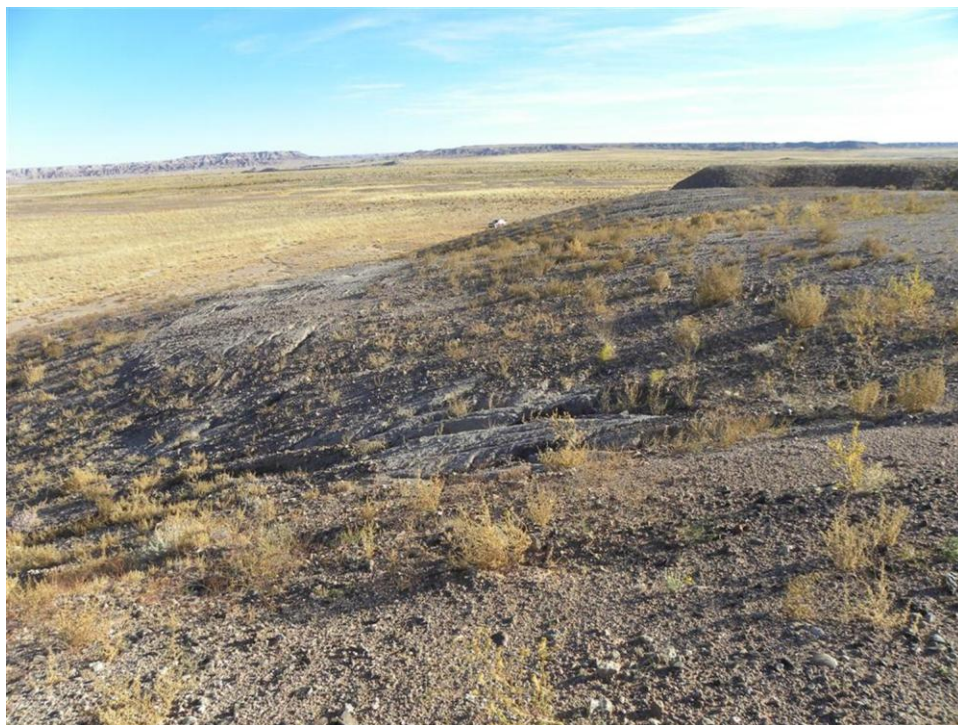
Photo 1. Jackpot No. 1 mine site

Large reclamation cap with drainage beneath, grey fine/granular material, some hot spots and minor erosion

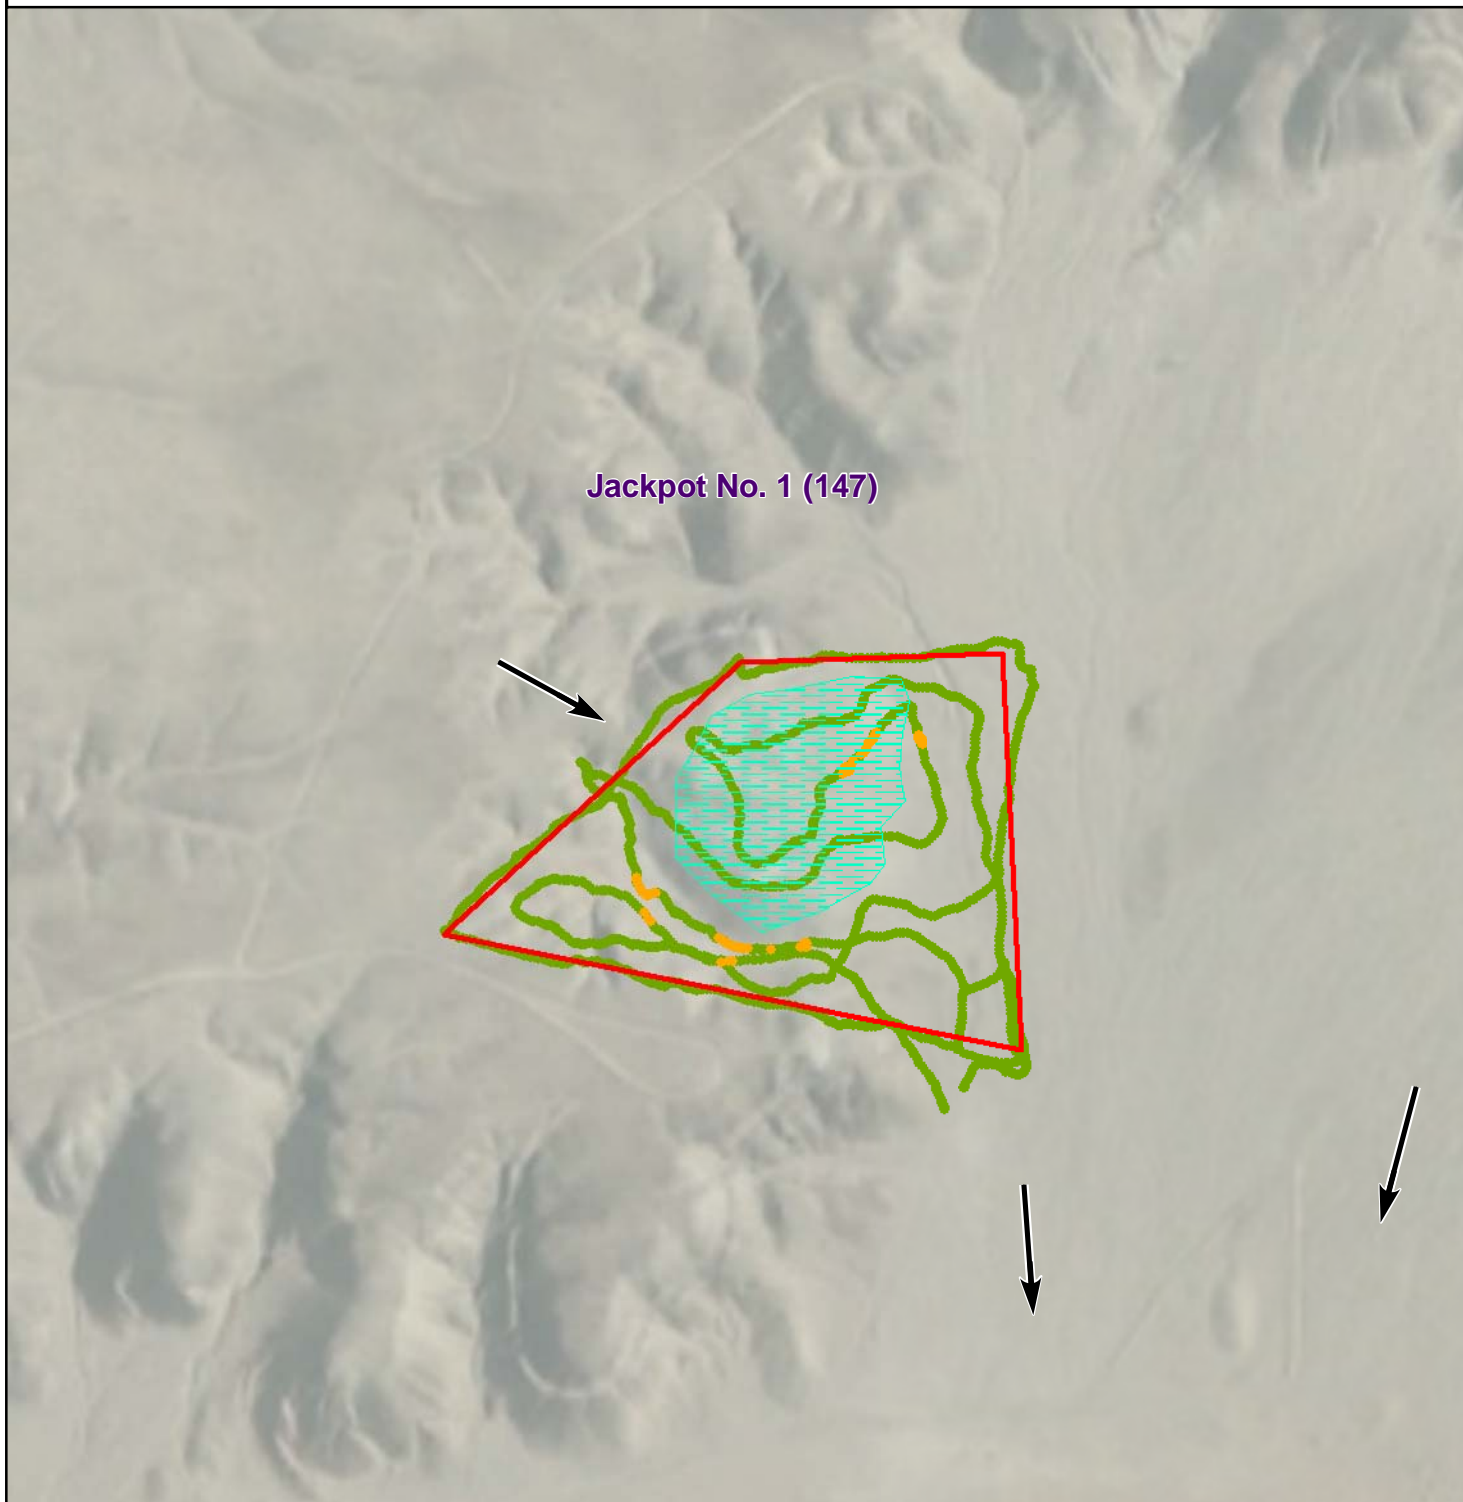
**Figure 1 - Gamma Radiation Measurements, Above Two Times Background  
Jackpot No. 1 (147)  
Coalmine Mesa Chapter, Navajo Nation**

A total of 2,000 gamma radiation measurements were collected from the mine site, ranging from 7,003 cpm to 905,754 cpm. The measurements collected at the reclamation cap were found mostly at background levels, with a few isolated hot spots with maximum levels of 900,000 cpm. The measurements are represented in Figures 1 and 2.

Gamma survey conducted 11/2010  
Measured as counts per minute (cpm)

Average background 11,281 cpm

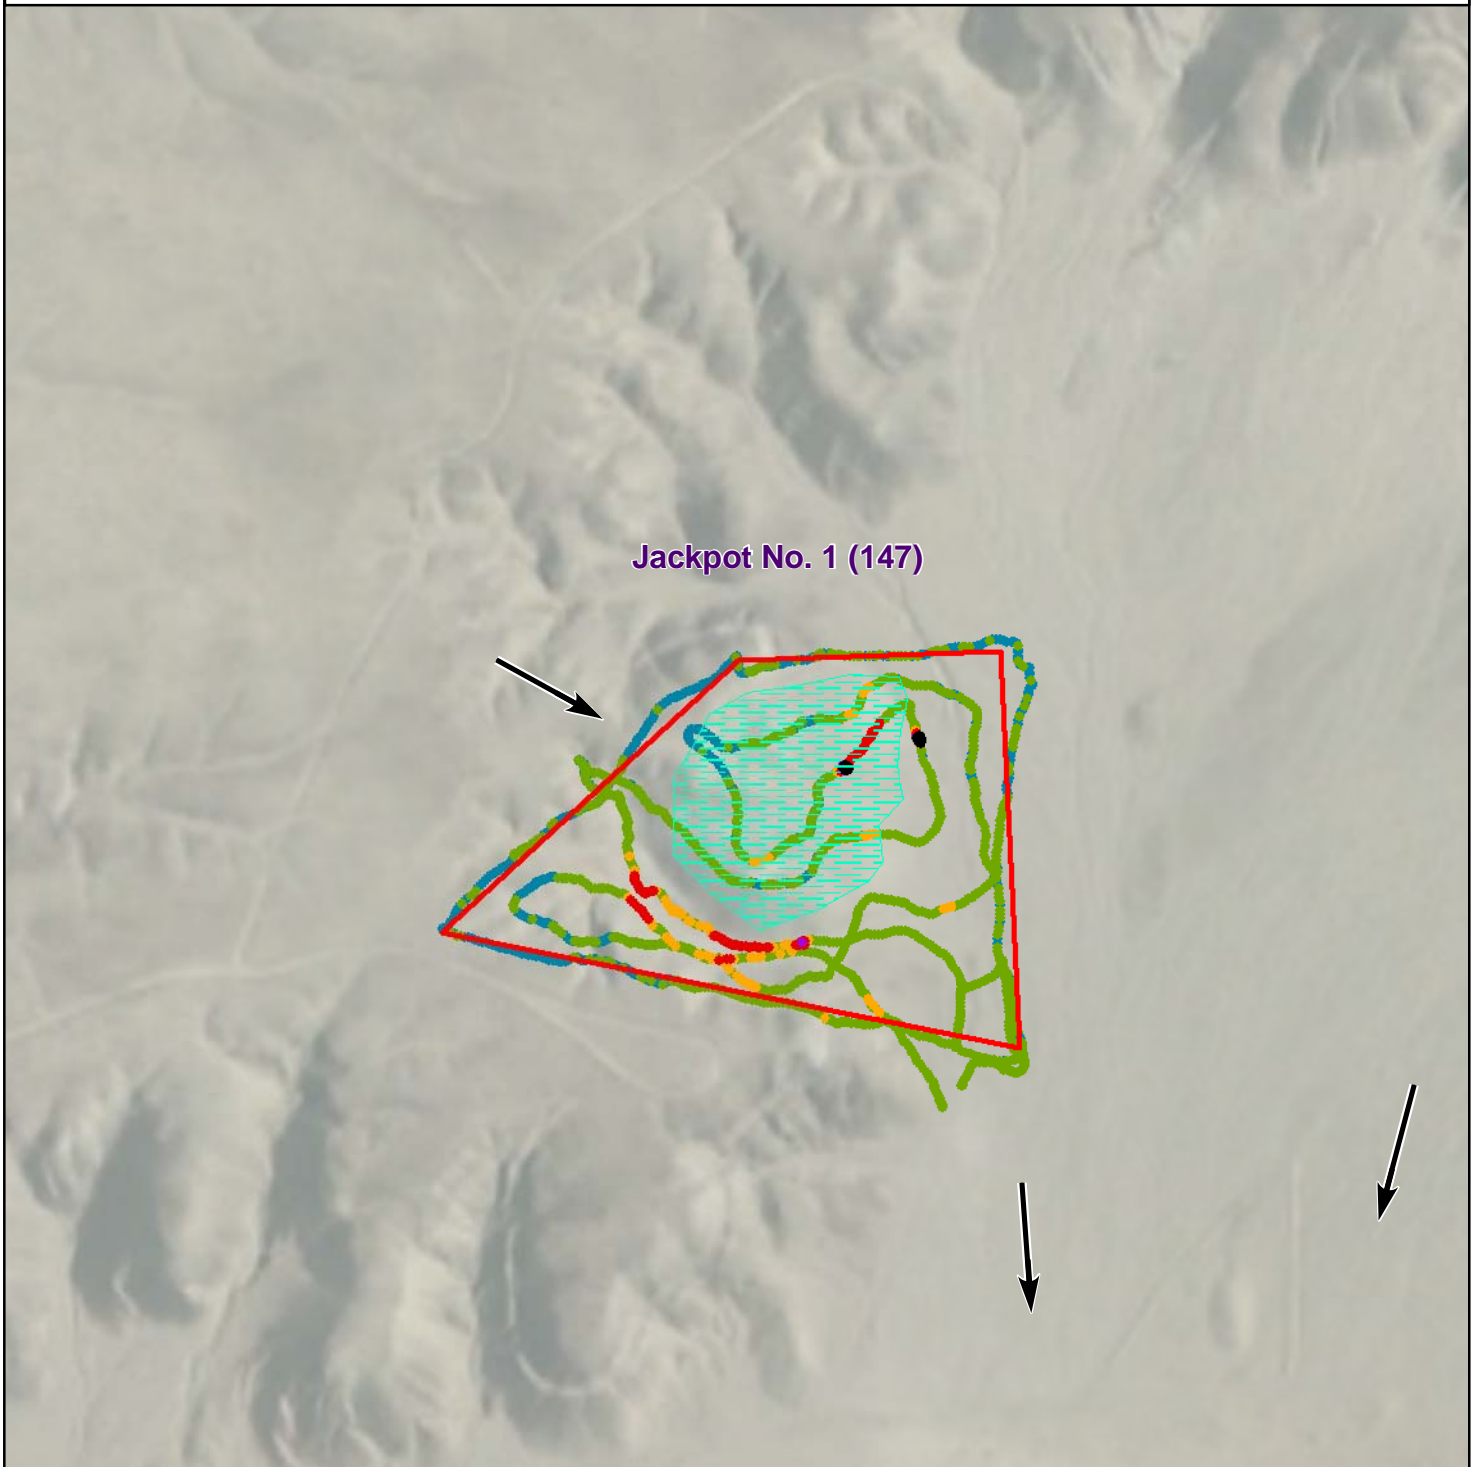
**Figure 2 - Gamma Radiation Measurements  
Jackpot No. 1 (147)  
Coalmine Mesa Chapter, Navajo Nation**

**Gamma survey conducted 11/2010  
Measured as counts per minute (cpm)**

**Average background 11,281 cpm**
